# Silver Rapids Lodge

## Environmental Assessment Worksheet *Fall Lake Township, Lake County, Minnesota*

June 17, 2026

PREPARED BY:  
ISG  
Nick McCabe  
Senior Environmental Scientist  
115 East Hickory Street + Suite 300  
Mankato, MN 56001  
507.387.6651  
Nick.McCabe@ISGInc.com

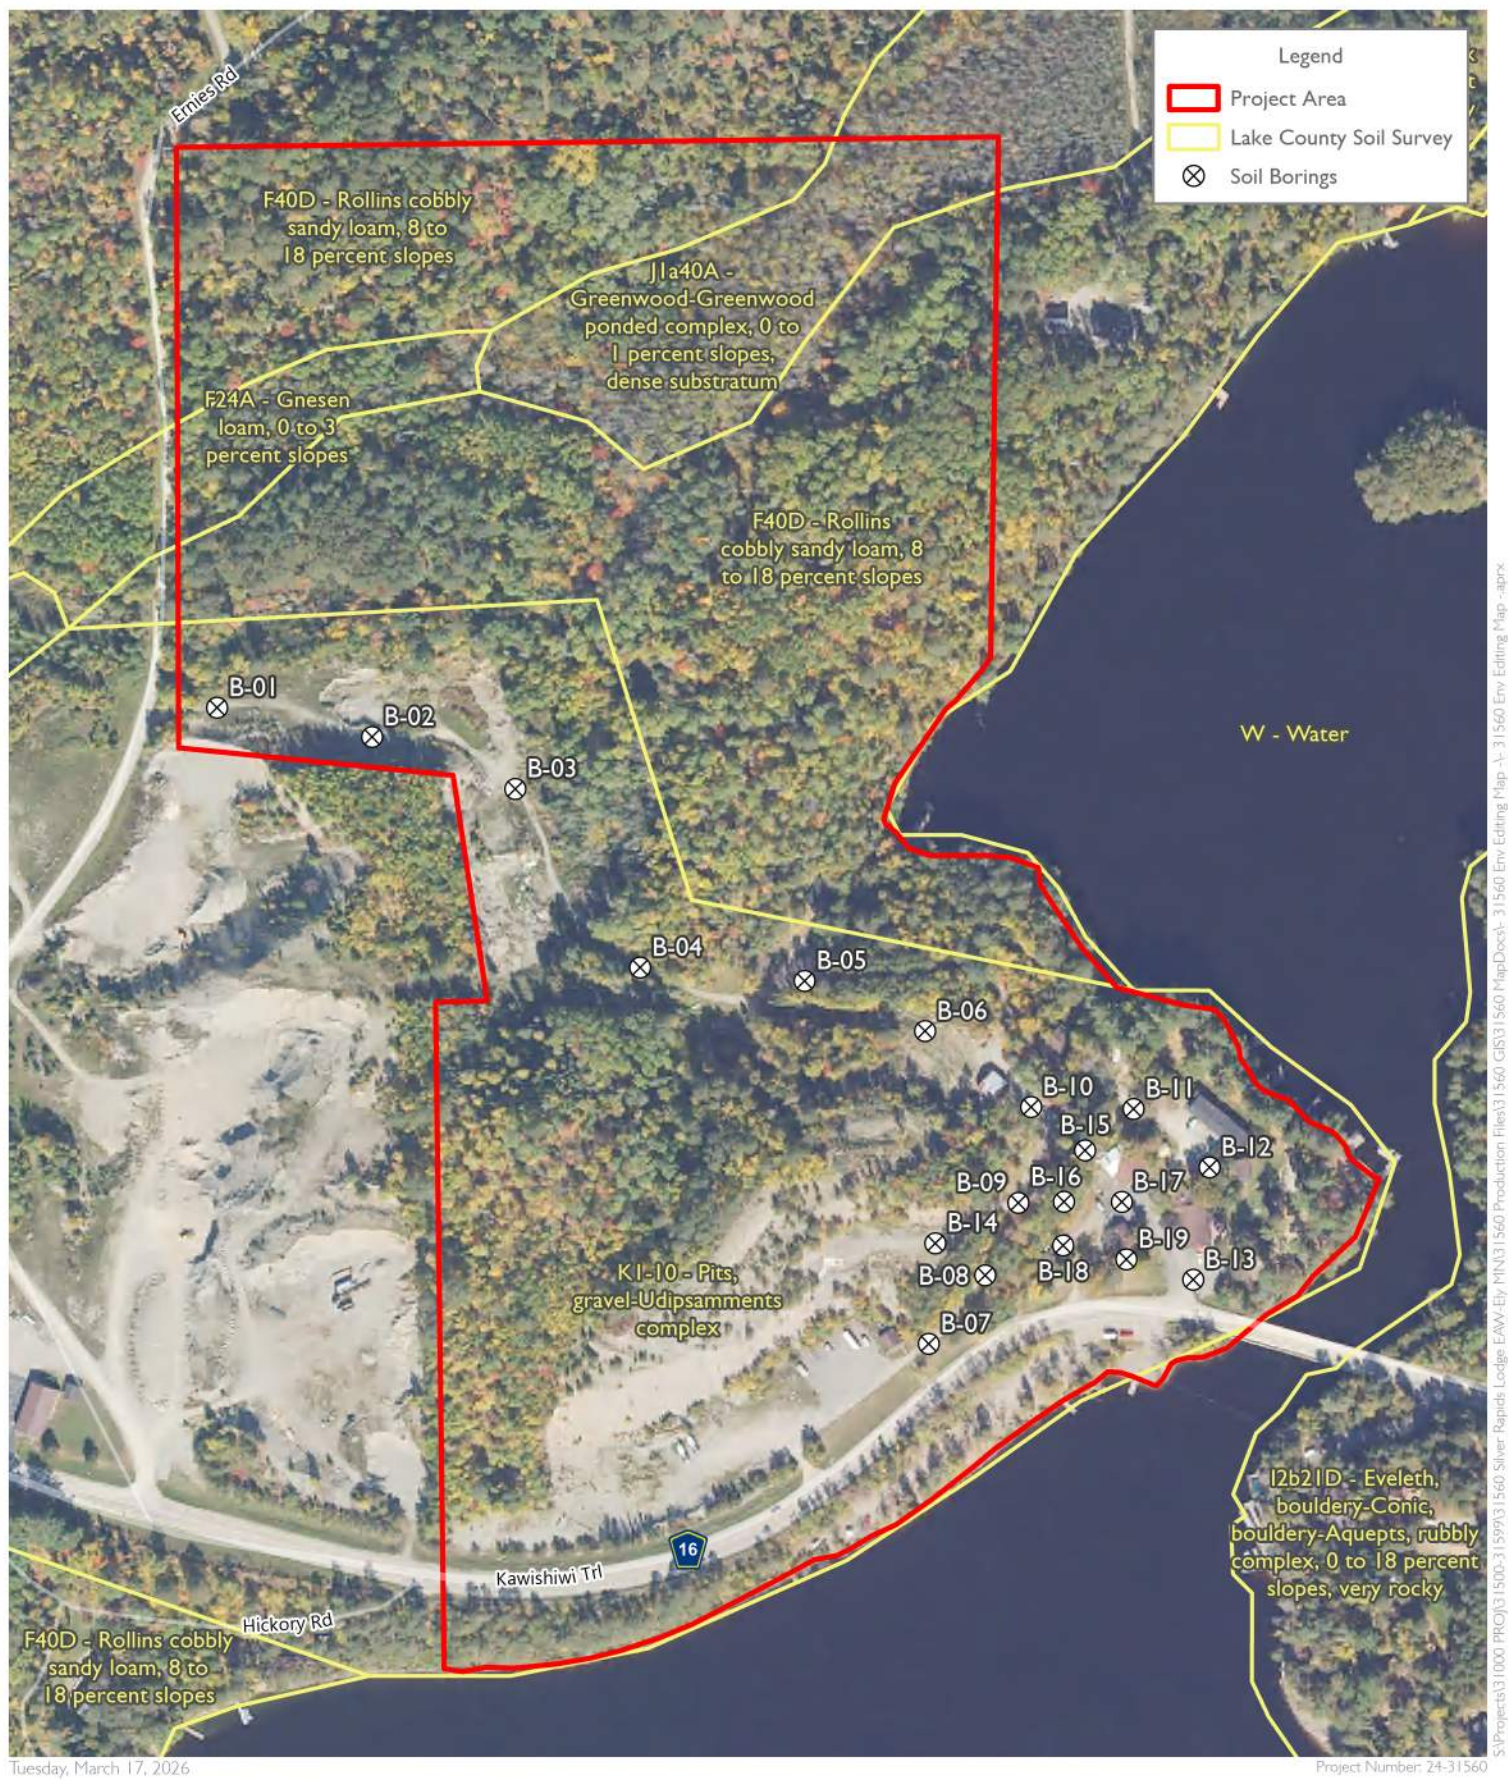
**Figure 7**  
**Lake County**  
**Soil Survey Map**  
**Silver Rapids Lodge**

Soils observed within the soil borings of the site's geotechnical evaluation consisted of different compositions of sand such as poorly graded sand or silty sand with gravel. Recommendations provided within the report for design and consideration have been taken into account in the project design.

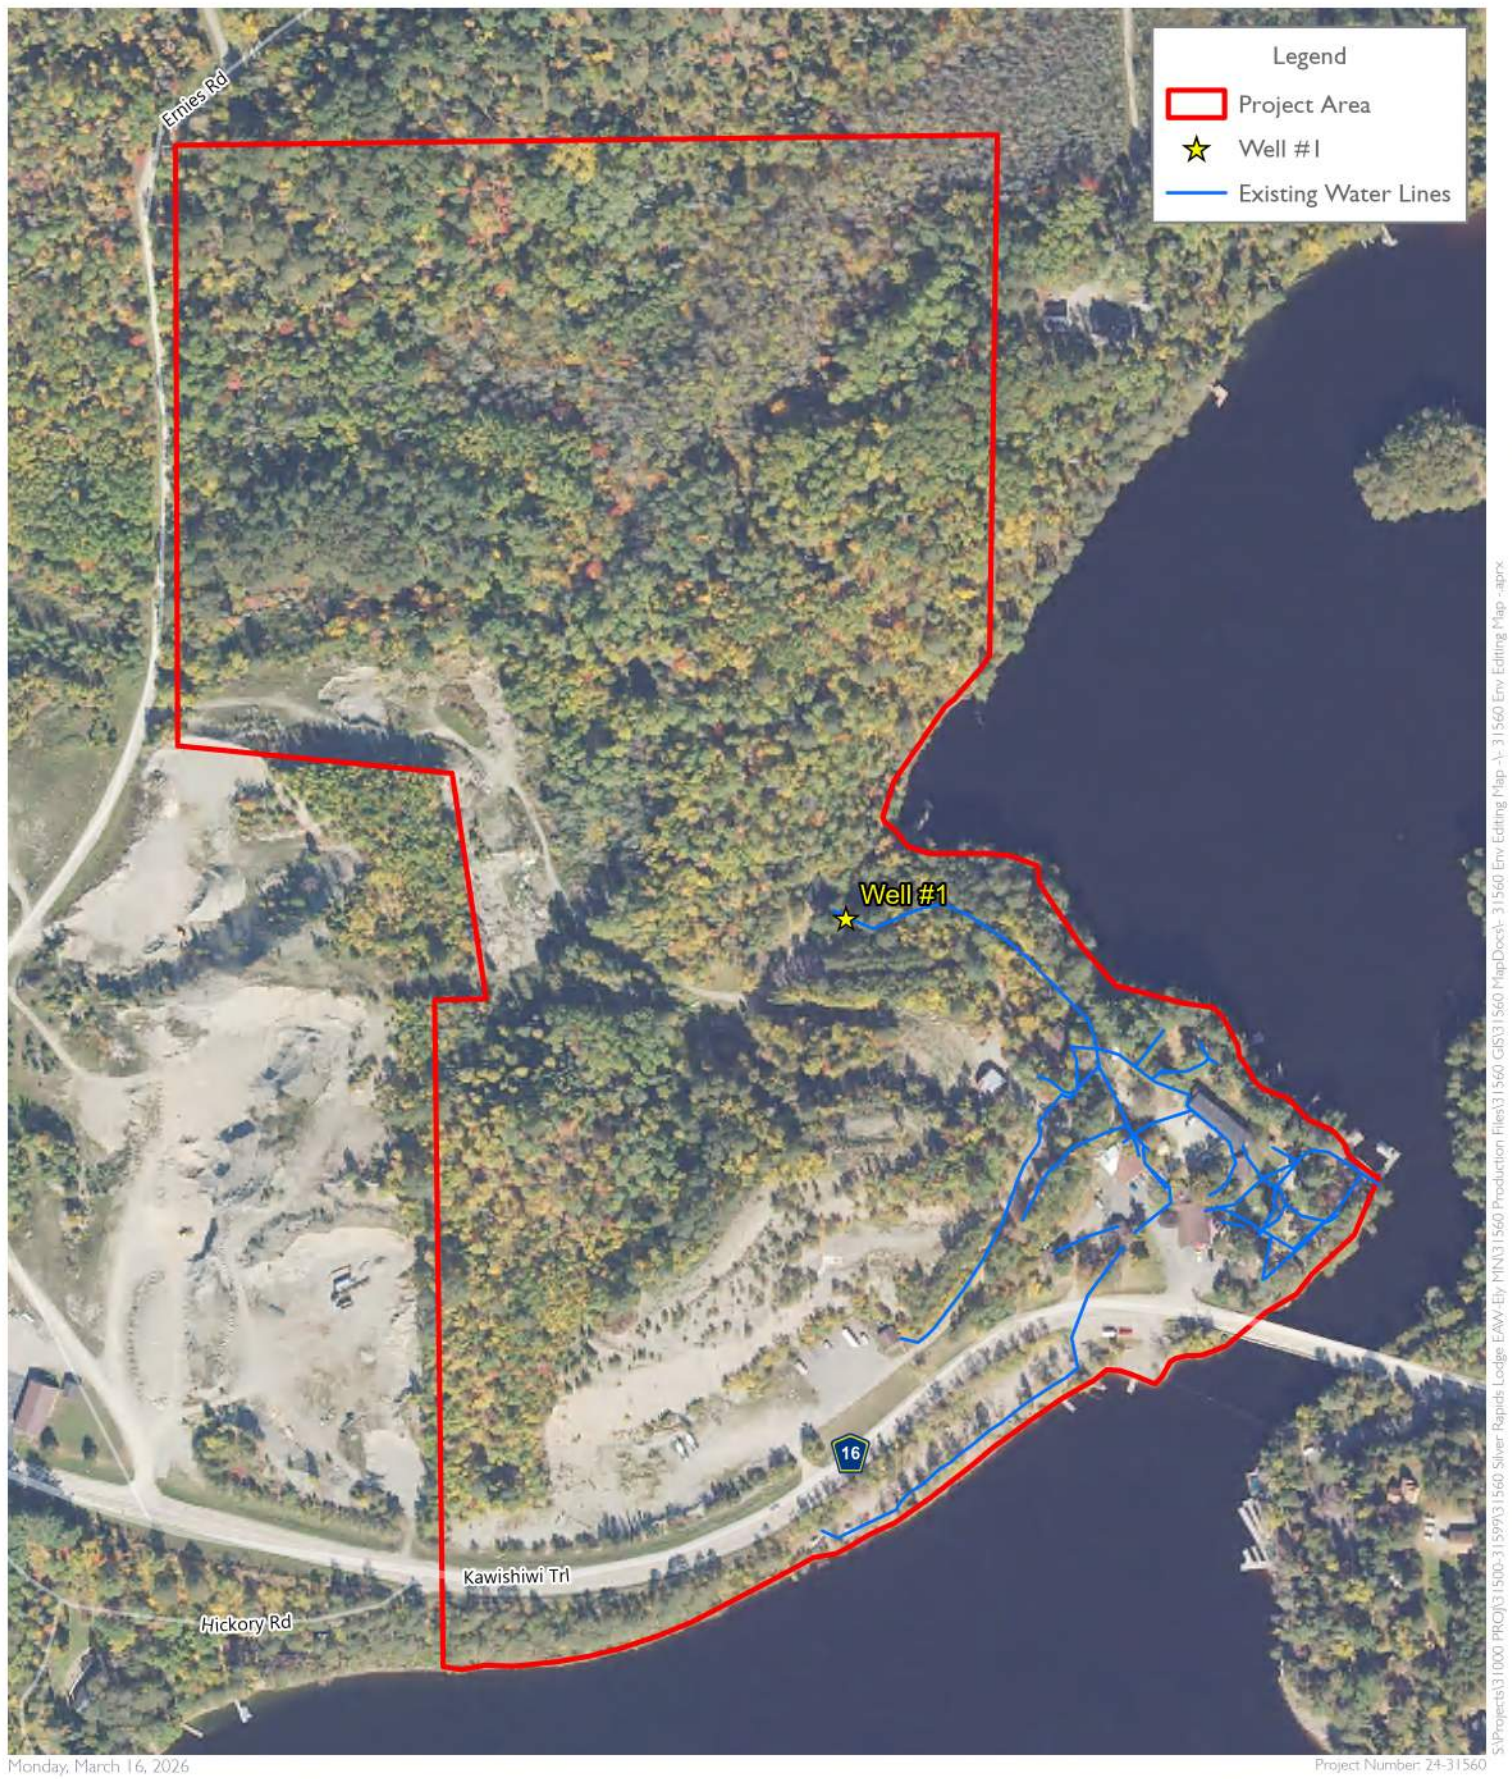
**Figure 12**  
**Water Supply System Map**  
**Silver Rapids Lodge**  
 Fall Lake Twp, Lake County, Minnesota

Water supply features are illustrated on **Appendix A – Figure 12**.

Figure 12. Water Supply System Map

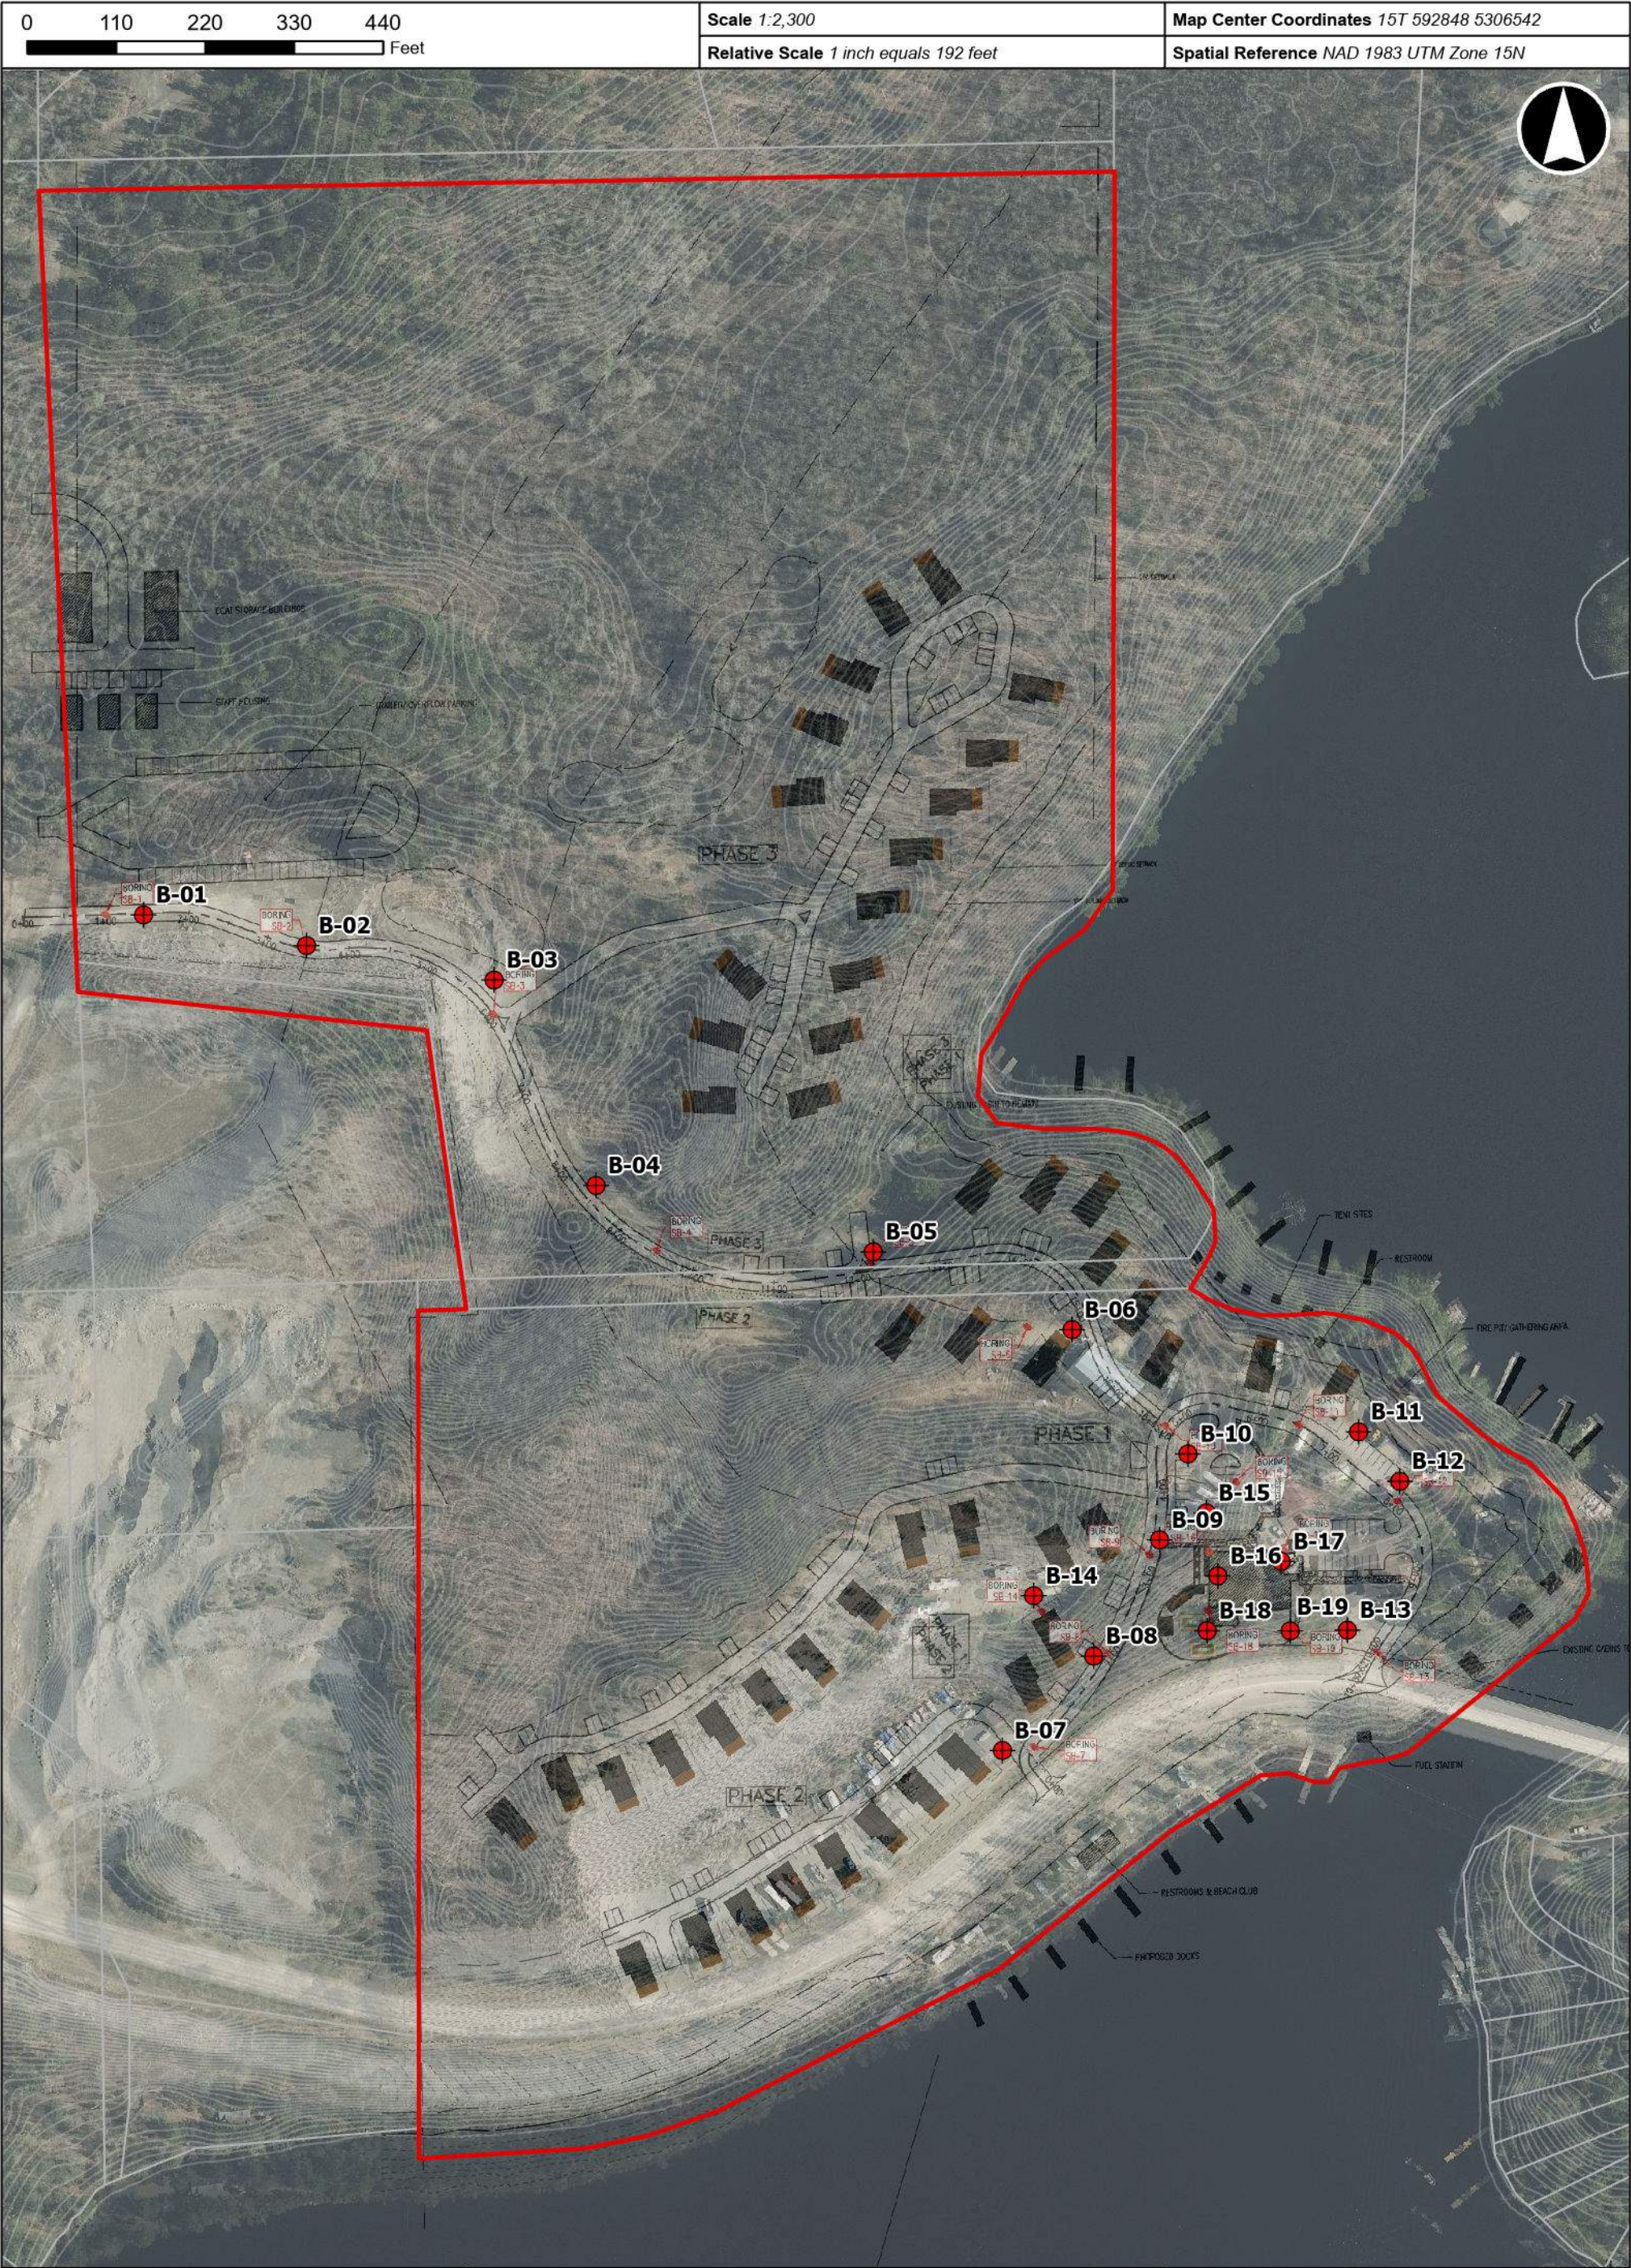
The project consists of a new development at the Silver Rapids Lodge located near the city of Ely, Minnesota. Silver Rapids Lodge SPE, LLC retained Northeast Technical Services, Inc. (NTS) to perform a subsurface geotechnical investigation to assess the soil conditions within the project area for new building construction, road design, and parking lots. The project site and soil boring locations are shown on Figure 1.

FIGURE 1: BORING LOCATION MAP

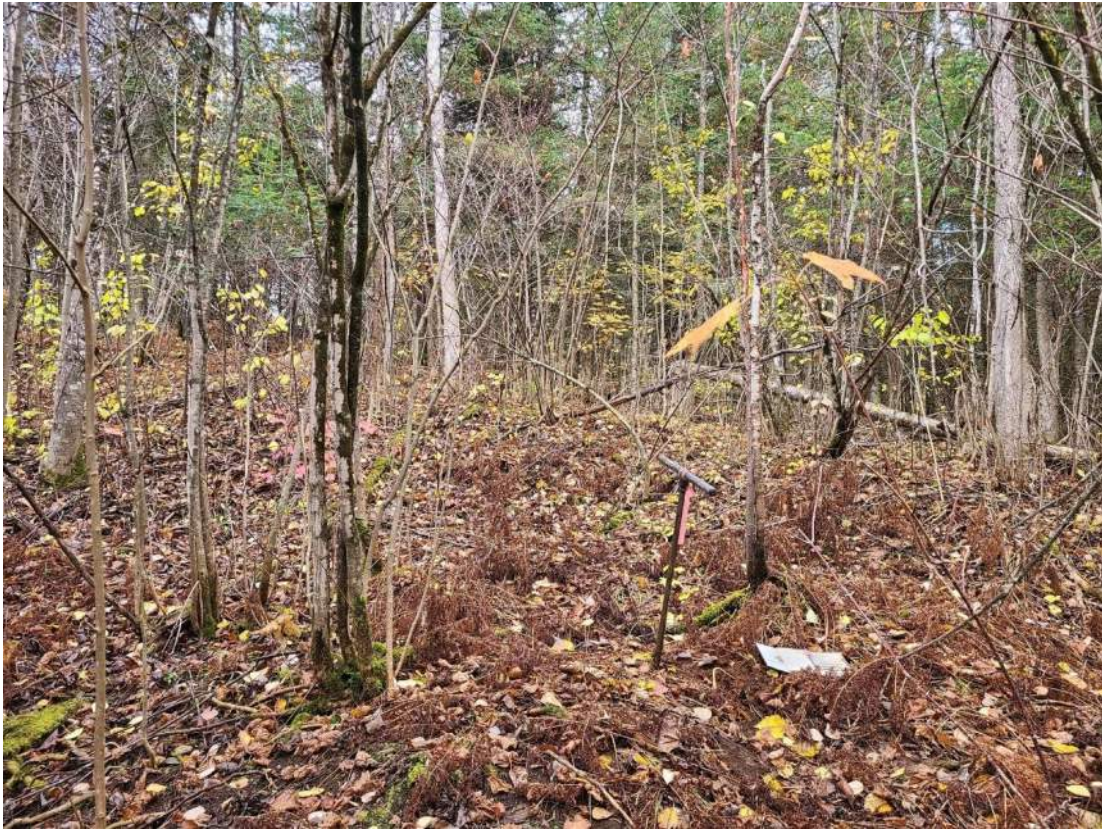
Photo 1: SR-A1U, showing hardwood forest plant community upslope from Wetland A.

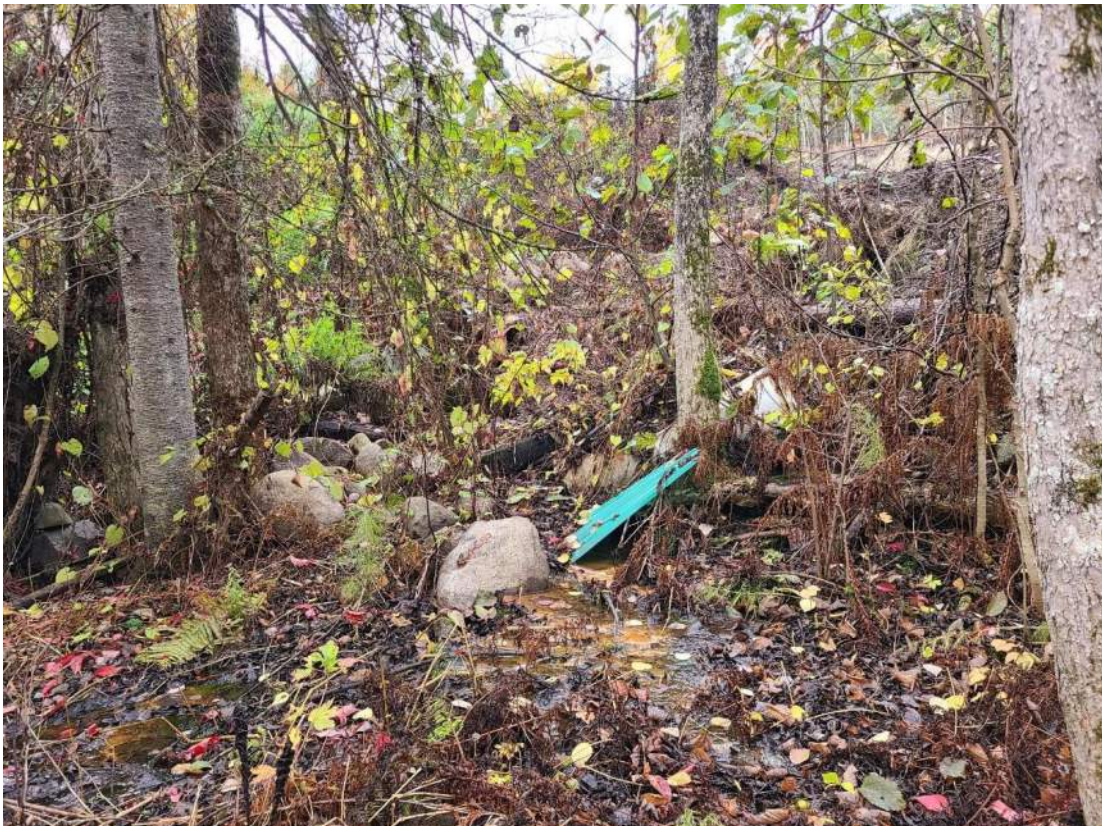
Photo 2: SR-A1W, showing seepage, surface water, and saturated conditions within Wetland A.

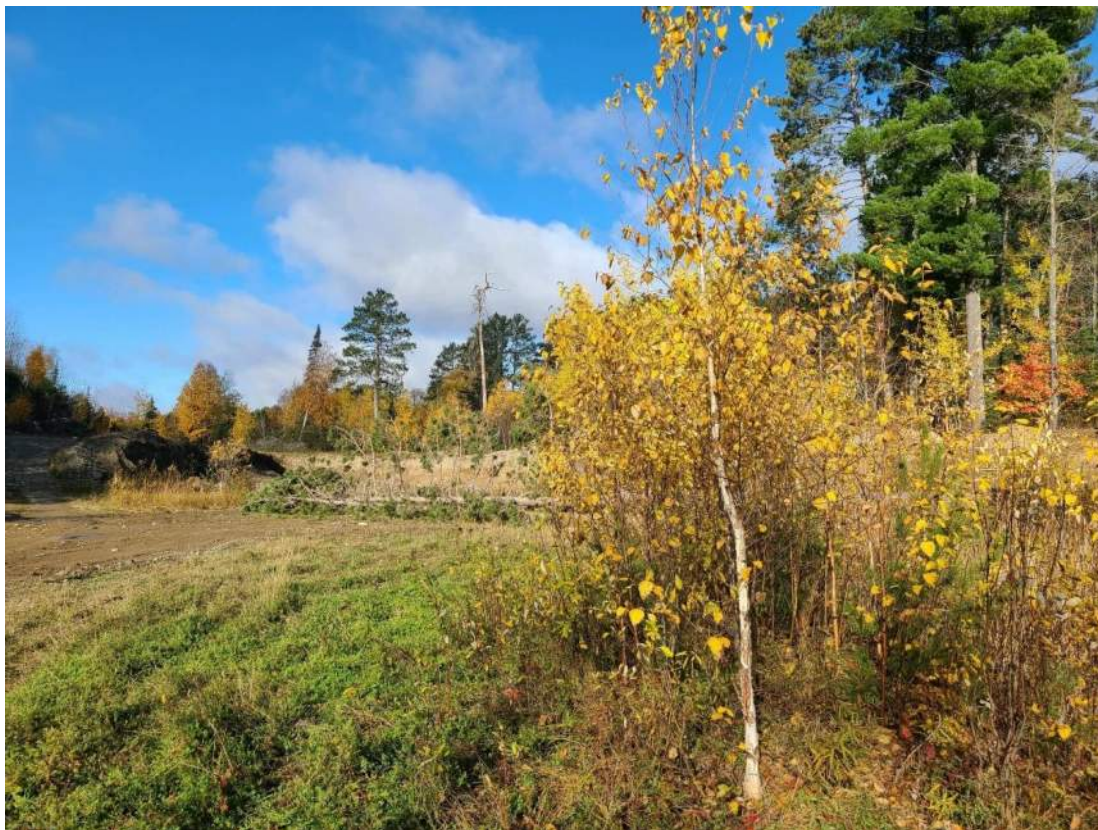
Photo 3:SR-B1U, showing upland plant community within gravel pit associated with Wetland B.

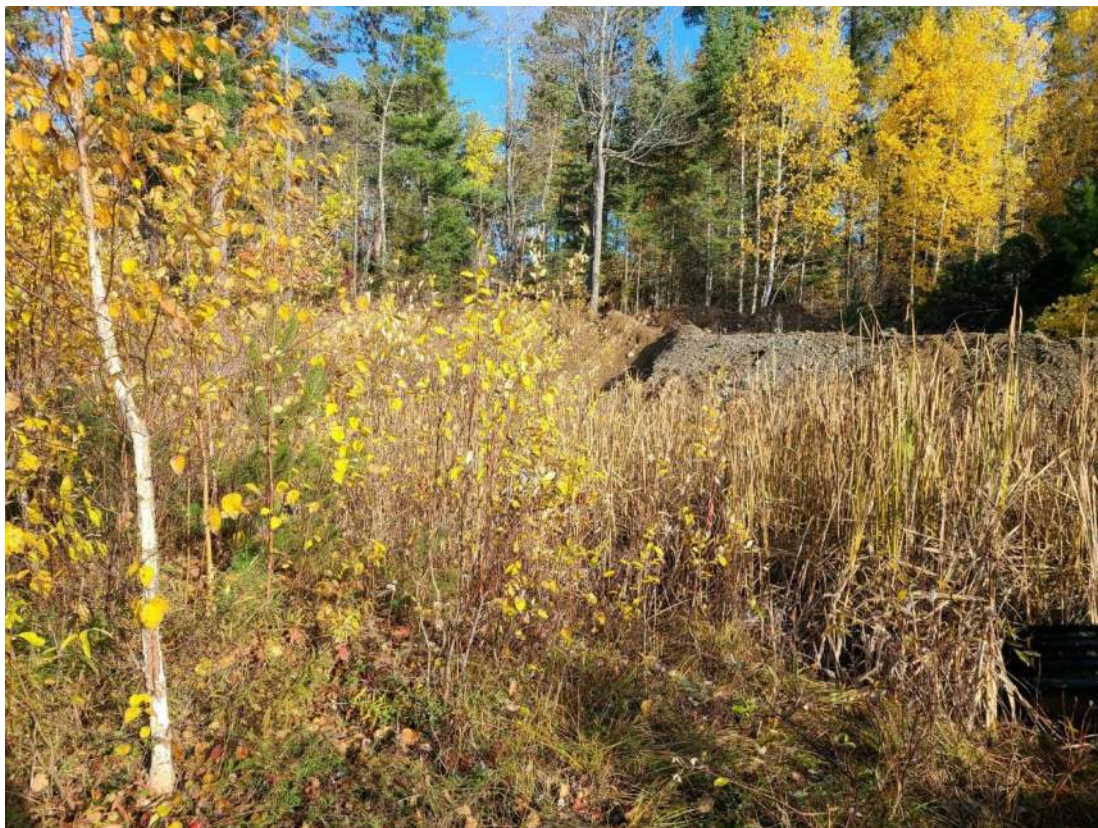
Photo 4:SR-B1W, showing Shallow Marsh within gravel borrow area within Wetland B.

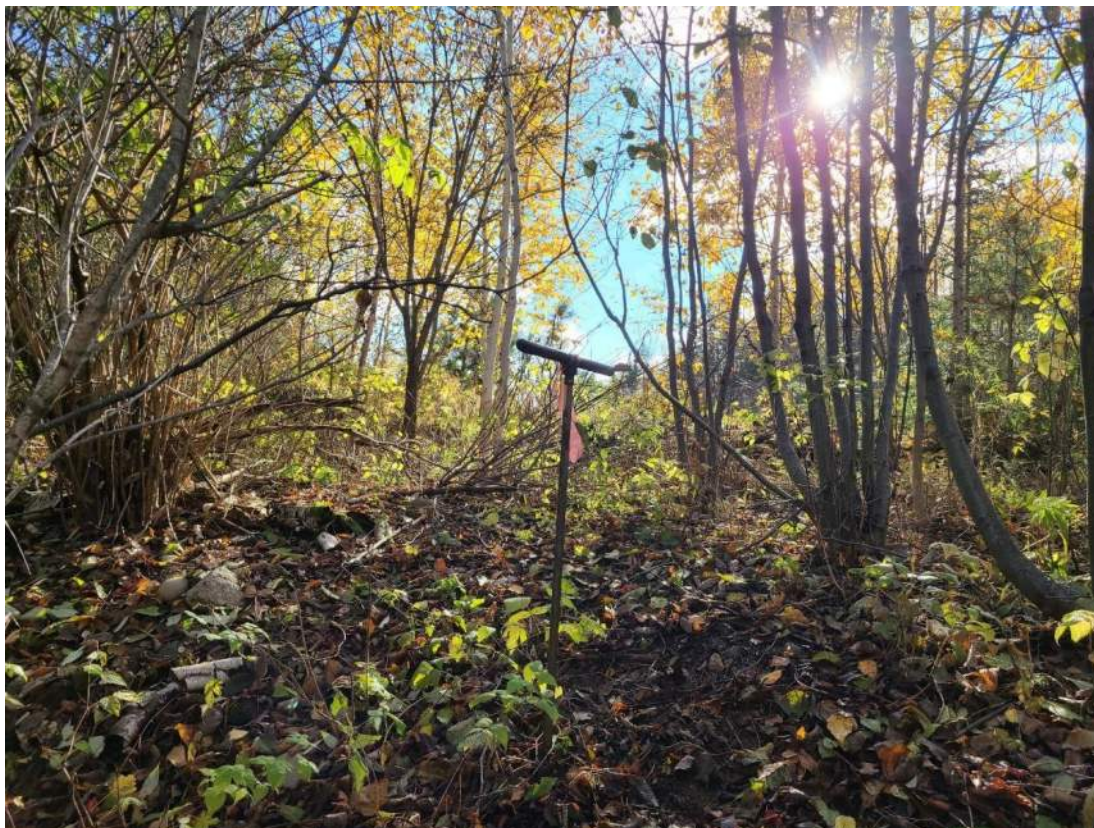
Photo 5:SR-C1U, showing hardwood forest plant community upslope from Wetland C.

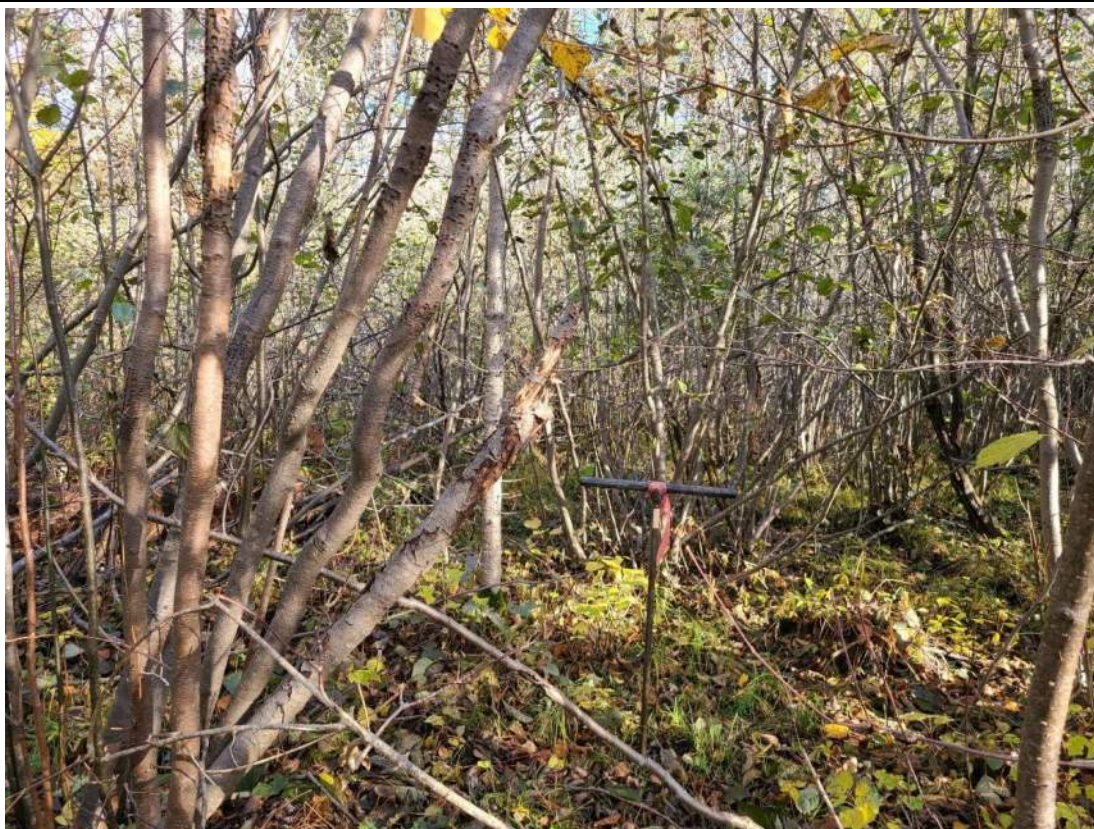
Photo 6:SR-C1W, showing Alder Thicket plant community within Wetland C.

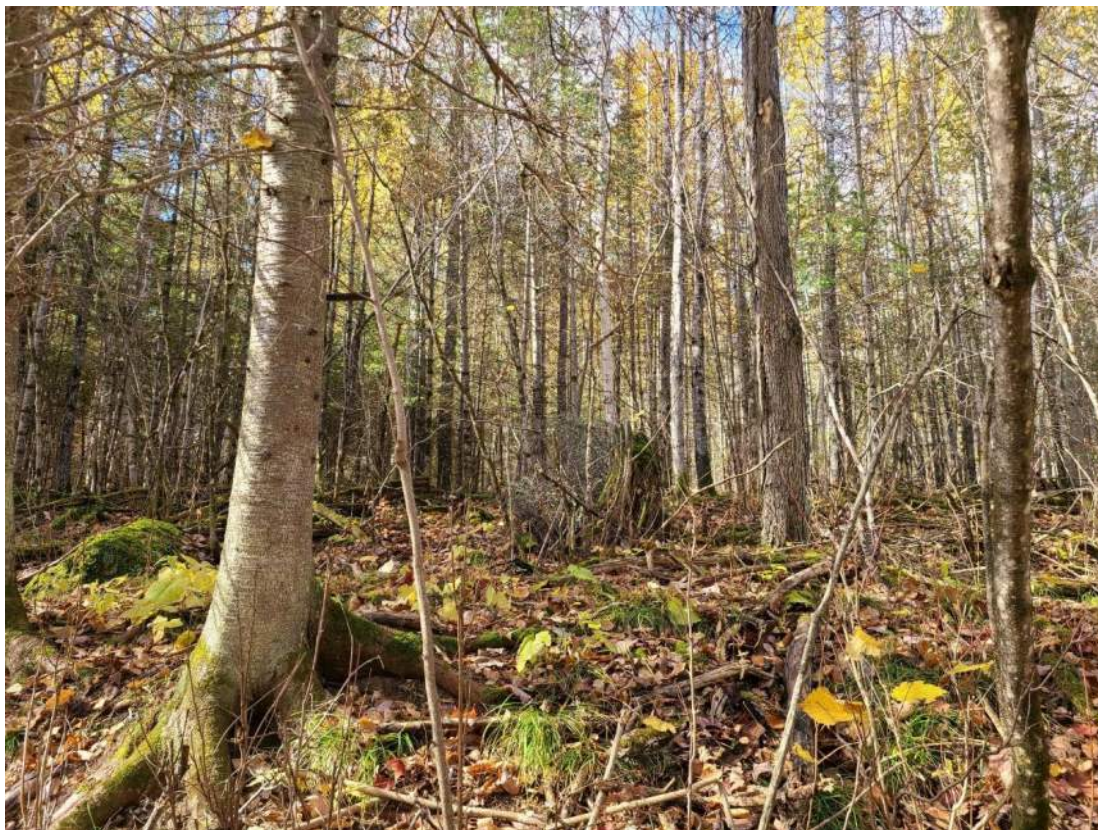
Photo 7:SR-C2U, showing hardwood forest plant community upslope from Wetland C.

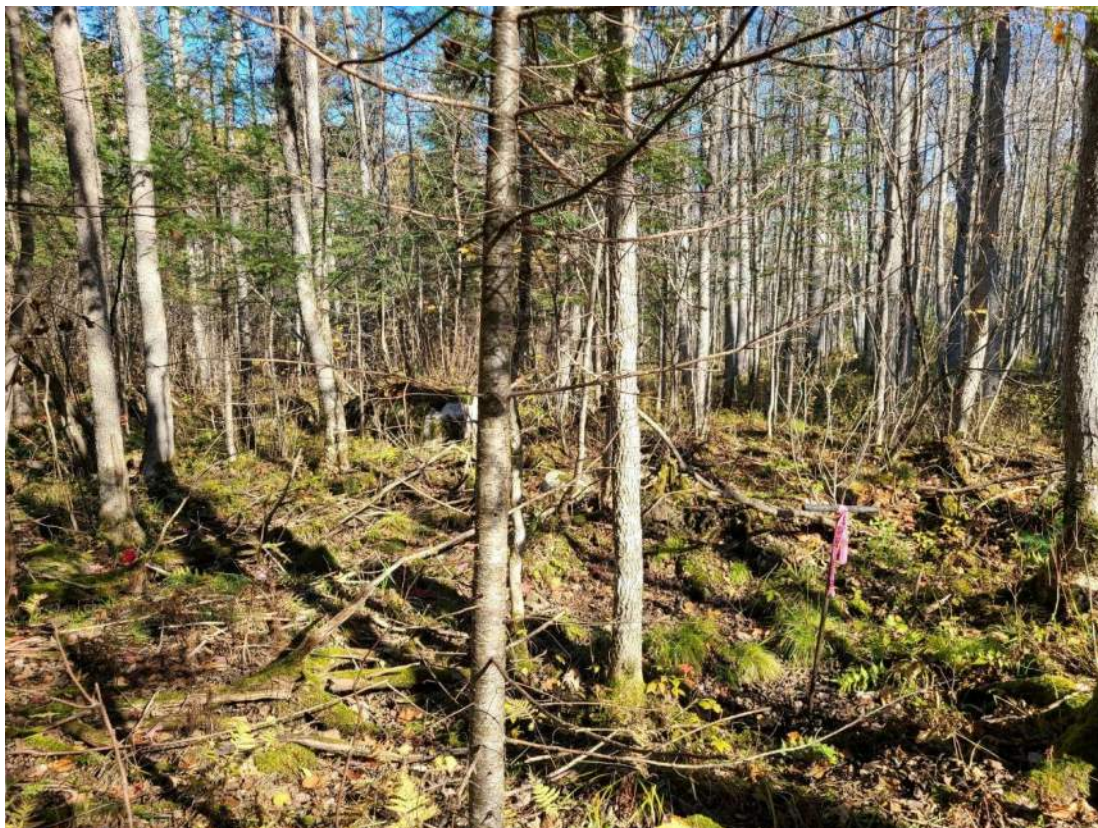
Photo 8:SR-C2W, showing Hardwood Swamp plant community within Wetland C.

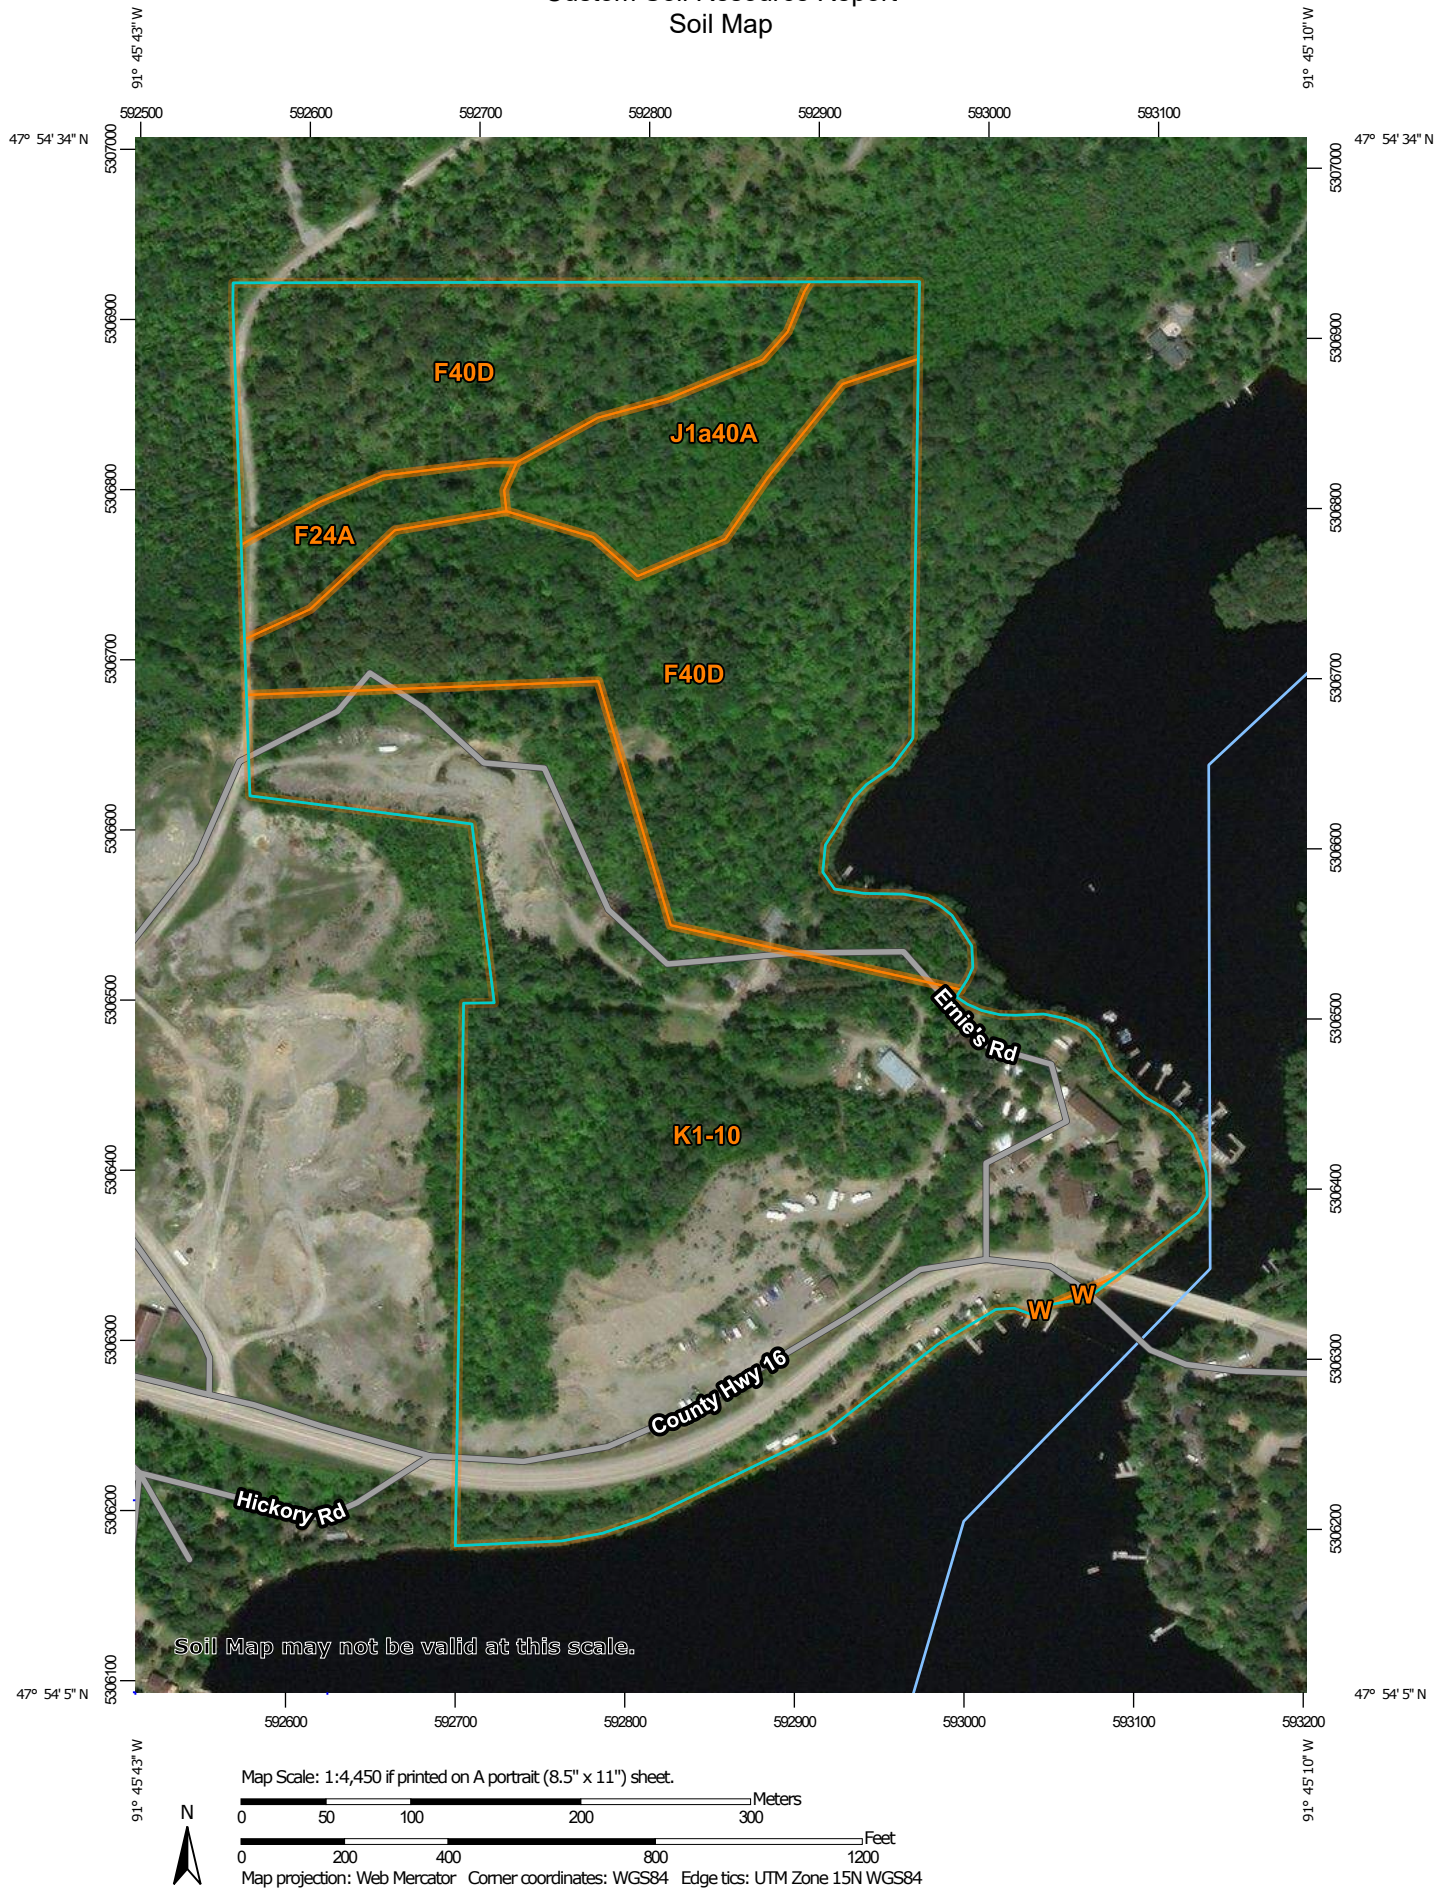
# Custom Soil Resource Report Soil Map

The NRCS Web Soil Survey was reviewed for mapped soil unit characteristics within the Project Area. Soil characteristics and attributes are provided in the following **Table 11-1** and illustrated on **Appendix A – Figure 7**.

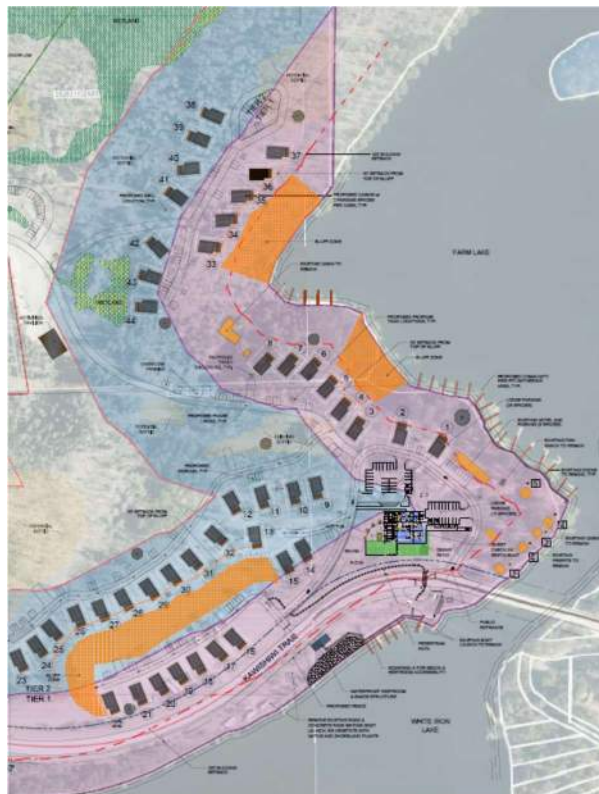
**Figure 1: Proposed Layout**

Silver Rapids Lodge is located at 459 Kawishiwi Trail in Ely, Minnesota. The Lodge has been in operation since 1919 and currently consists of 12 cabins, several motel/lodge rooms, a bar/restaurant, and RV/tent camping sites. The Lodge is now considering an expansion as shown in **Figure 1**.
